FINAL REPORT

INVESTIGATION OF THE REACTION OF TITANIUM WITH HYDROGEN

NATIONAL AERONAUTICS & SPACE ADMINISTRATION

Contract NAS 9-7549

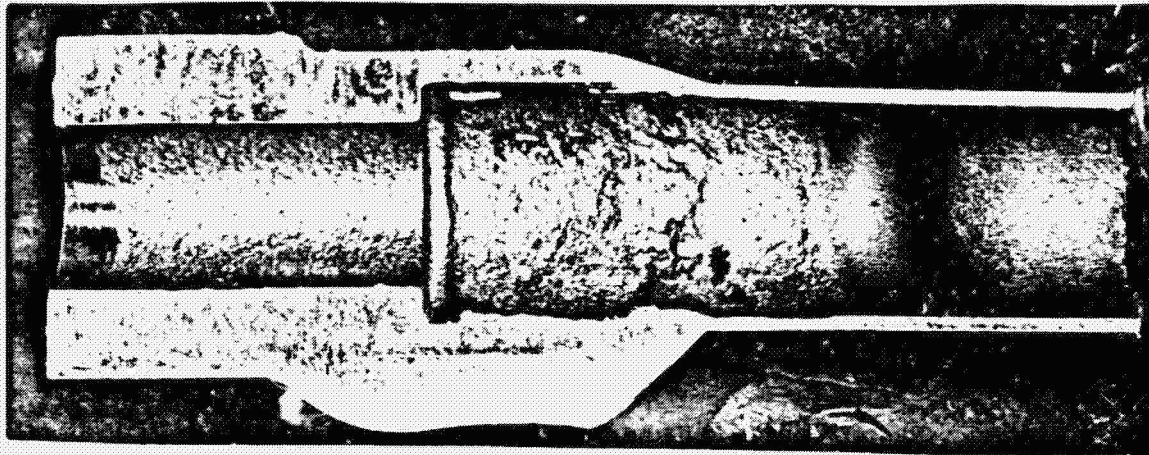
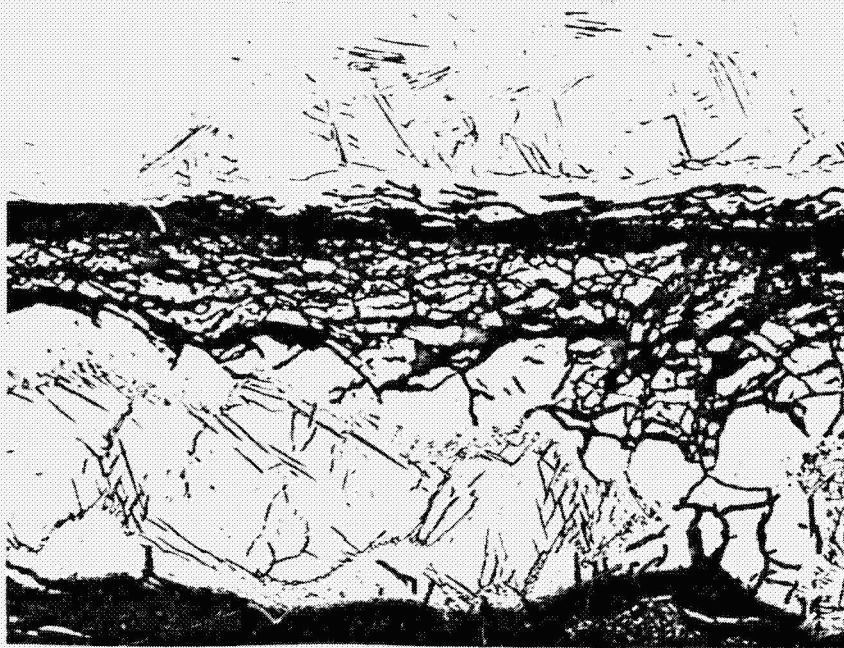
Figure 1. FAILED UNALLOYED TITANIUM TUBING FROM LIQUID HYDROGEN TANK

Severe erosion and pitting of the tubing occurred in the vicinity of the welds, as shown in Figure 1, in areas exposed predominantly to gaseous hydrogen. Pitting was so severe as to lead to perforation of the tube wall on several of the tanks. The pitting was the result of the spalling of surface hydrides formed by reaction between hydrogen gas and titanium. Metallographic study showed hydriding along a considerable portion of the interior surface of some of the tubing, as far as 7 inches from the nearest weld. The hydride in this case was generally present as a thin continuous layer, as shown in Figure 2. No problems were encountered in areas of the tanks exposed to gaseous hydrogen at temperatures and pressures which did not exceed 150 F and 300 psi, respectively.

(a) Photograph of a tank fitting after sectioning to show internal attack

(b) Localized heavy hydriding near weld area of tank fitting

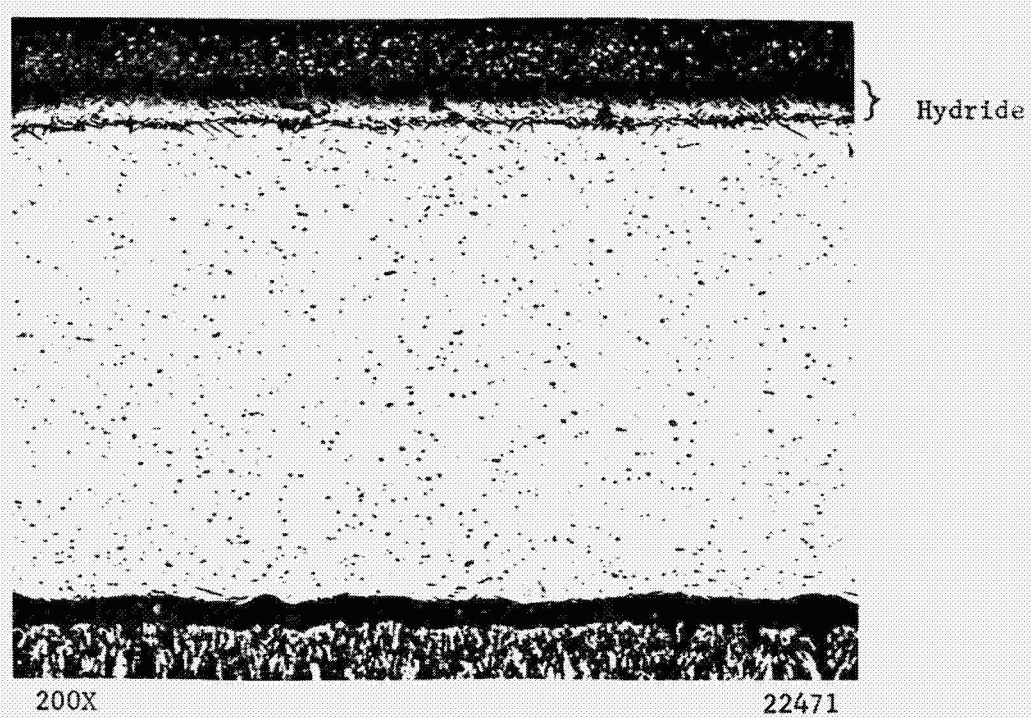
FIGURE 2. HYDRIDE ON INSIDE SURFACE OF UNALLOYED  
TITANIUM TUBE

Hydride averaged 1.2 mils in thickness.

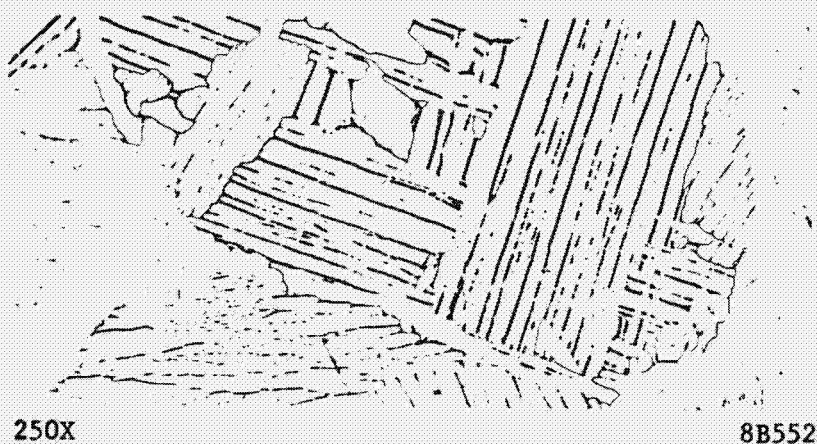
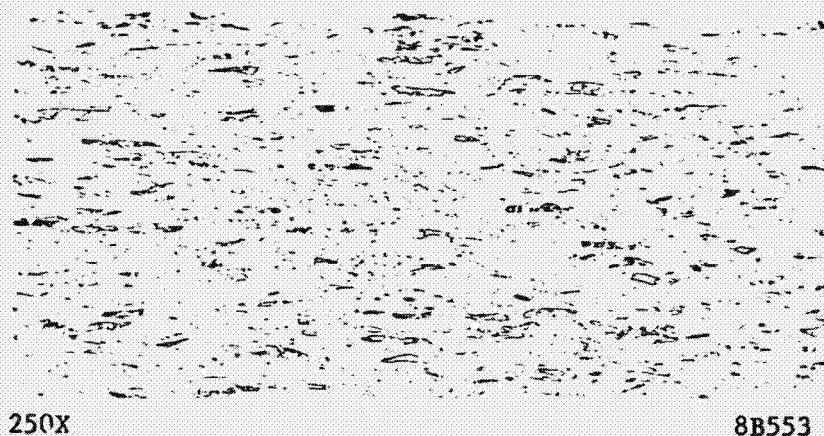
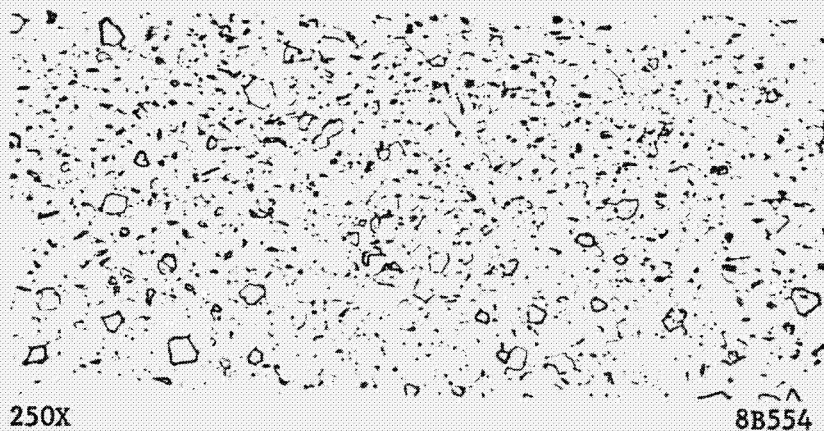
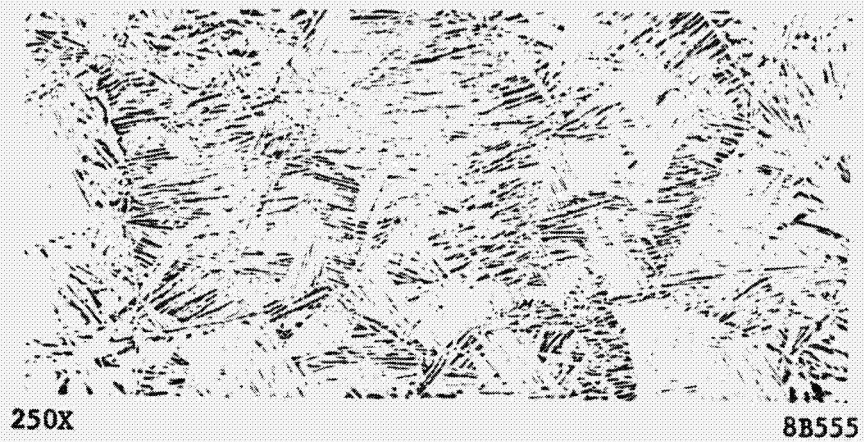
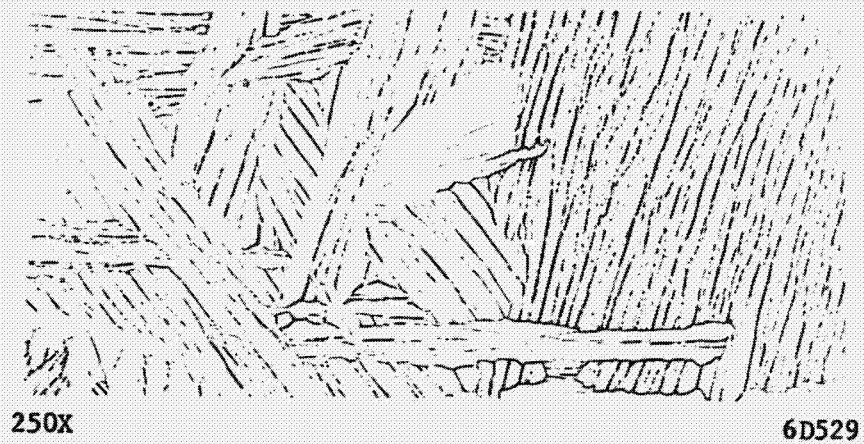
FIGURE 3. MICROSTRUCTURES OF FIVE OF THE TITANIUM MATERIALS USED IN THIS WORK

(a) Ti-50A  
Coarse acicular  
structure

(b) Ti-50A  
Cold-rolled  
structure

(c) Ti-50A  
Fine equiaxed  
structure

(d) Ti-6Al-4V  
Coarse acicular  
structure

(e) Ti-5Al-2.5Sn  
Coarse acicular  
structure

Samples were prepared in a variety of sizes and heat treated conditions. These sizes and conditions and specific studies for which they were used are summarized in Table 2. Figure 3 shows typical microstructures examined in this work.

- (1) Annealed 1/2 hour at 1750 F and slow cooled\* to produce a coarse acicular alpha microstructure.
- (2) Annealed 1/2 hour at 1200 F and air cooled to produce a fine-grained equiaxed alpha microstructure.
- (3) Annealed 1/2 hour at 1750 F and water quenched to produce a fine acicular alpha structure.
- (4) No heat treatment; samples were cold rolled 53 percent.
- (5) No treatment (mill annealed equiaxed structure).

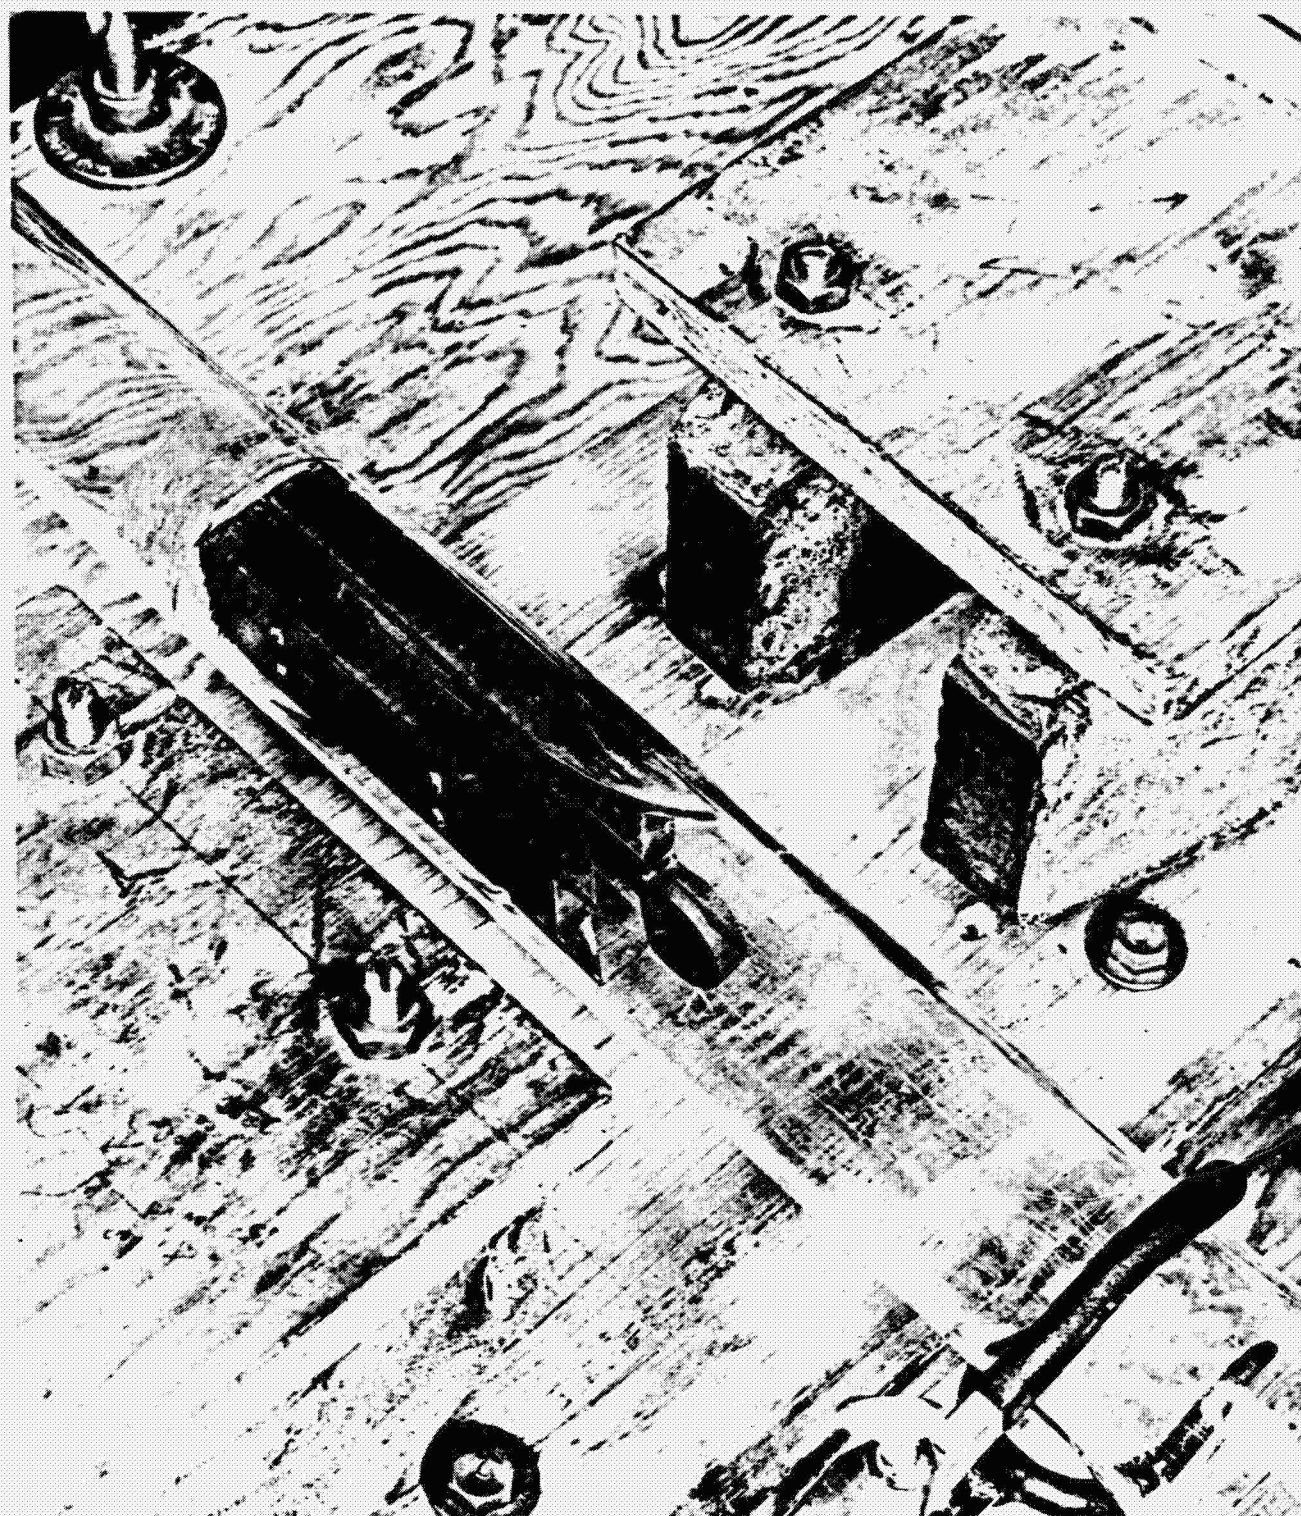
FIGURE 6. METHOD OF PRODUCING STRESS IN TITANIUM SAMPLE IN GLASS SYSTEM

Sample is shown bolted in holder inside the Vycor reaction tube positioned between the two oscillating magnets. This was part of the glass vacuum system.

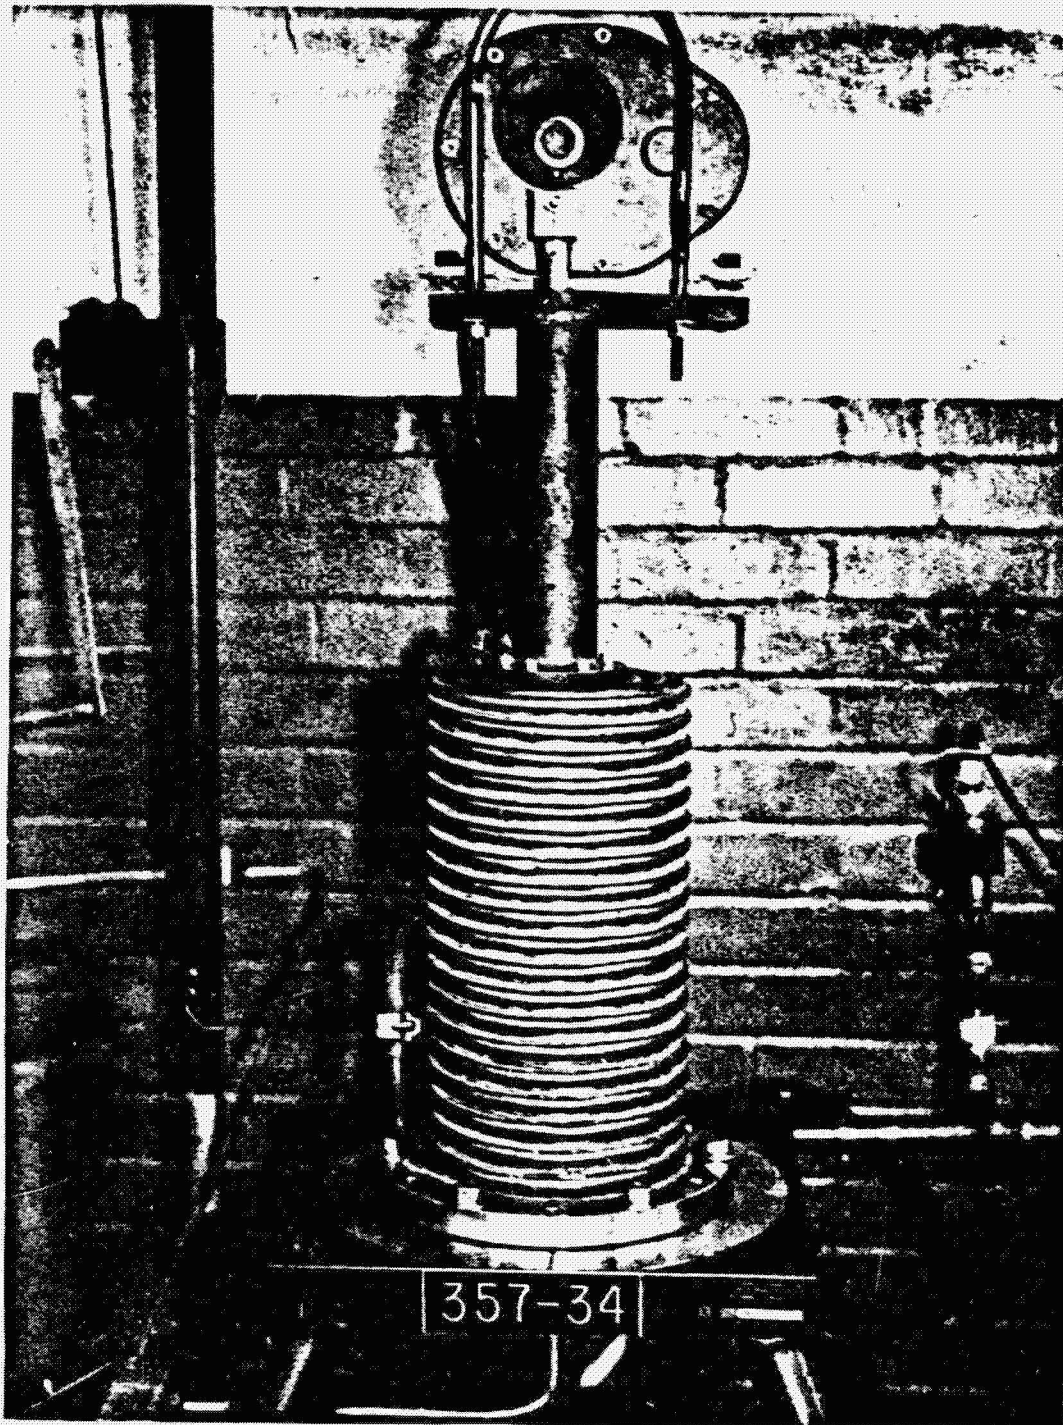
FIGURE 7. APPARATUS USED FOR WORK ABOVE ATMOSPHERIC PRESSURE

The lower section was used for hydrogen exposure of stationary samples. The upper section was added in order to gall samples while under pressure.

Unstressed (300 psig, near room temperature). Part of the experimental work on unstressed samples at greater than atmospheric pressures of hydrogen and near room temperature was done in the stainless steel chamber shown in Figure 7. The inside height was 11-1/2 inches and inside diameter was 5 inches. The chamber was sealed with an O-ring to a base plate in which tubing was connected for evacuation and gas addition. The outside of the chamber was wound with copper tubing through which water was circulated to maintain temperatures up to 130 F used in this work. Evacuation was accomplished through 1-inch copper lines by means of an oil diffusion pump and a mechanical pump. A vacuum of about 0.03 microns was obtained before the addition of the hydrogen and was read on a Consolidated Electrodynamics Discharge Gage. Hydrogen was added through a liquid nitrogen trap and the pressure was read on a 10-inch Heise Bourdon gage with readings accurate to 1 psig. The samples were exposed to hydrogen in groups of up to 24 at one time. The samples were individually held on a glass rack.

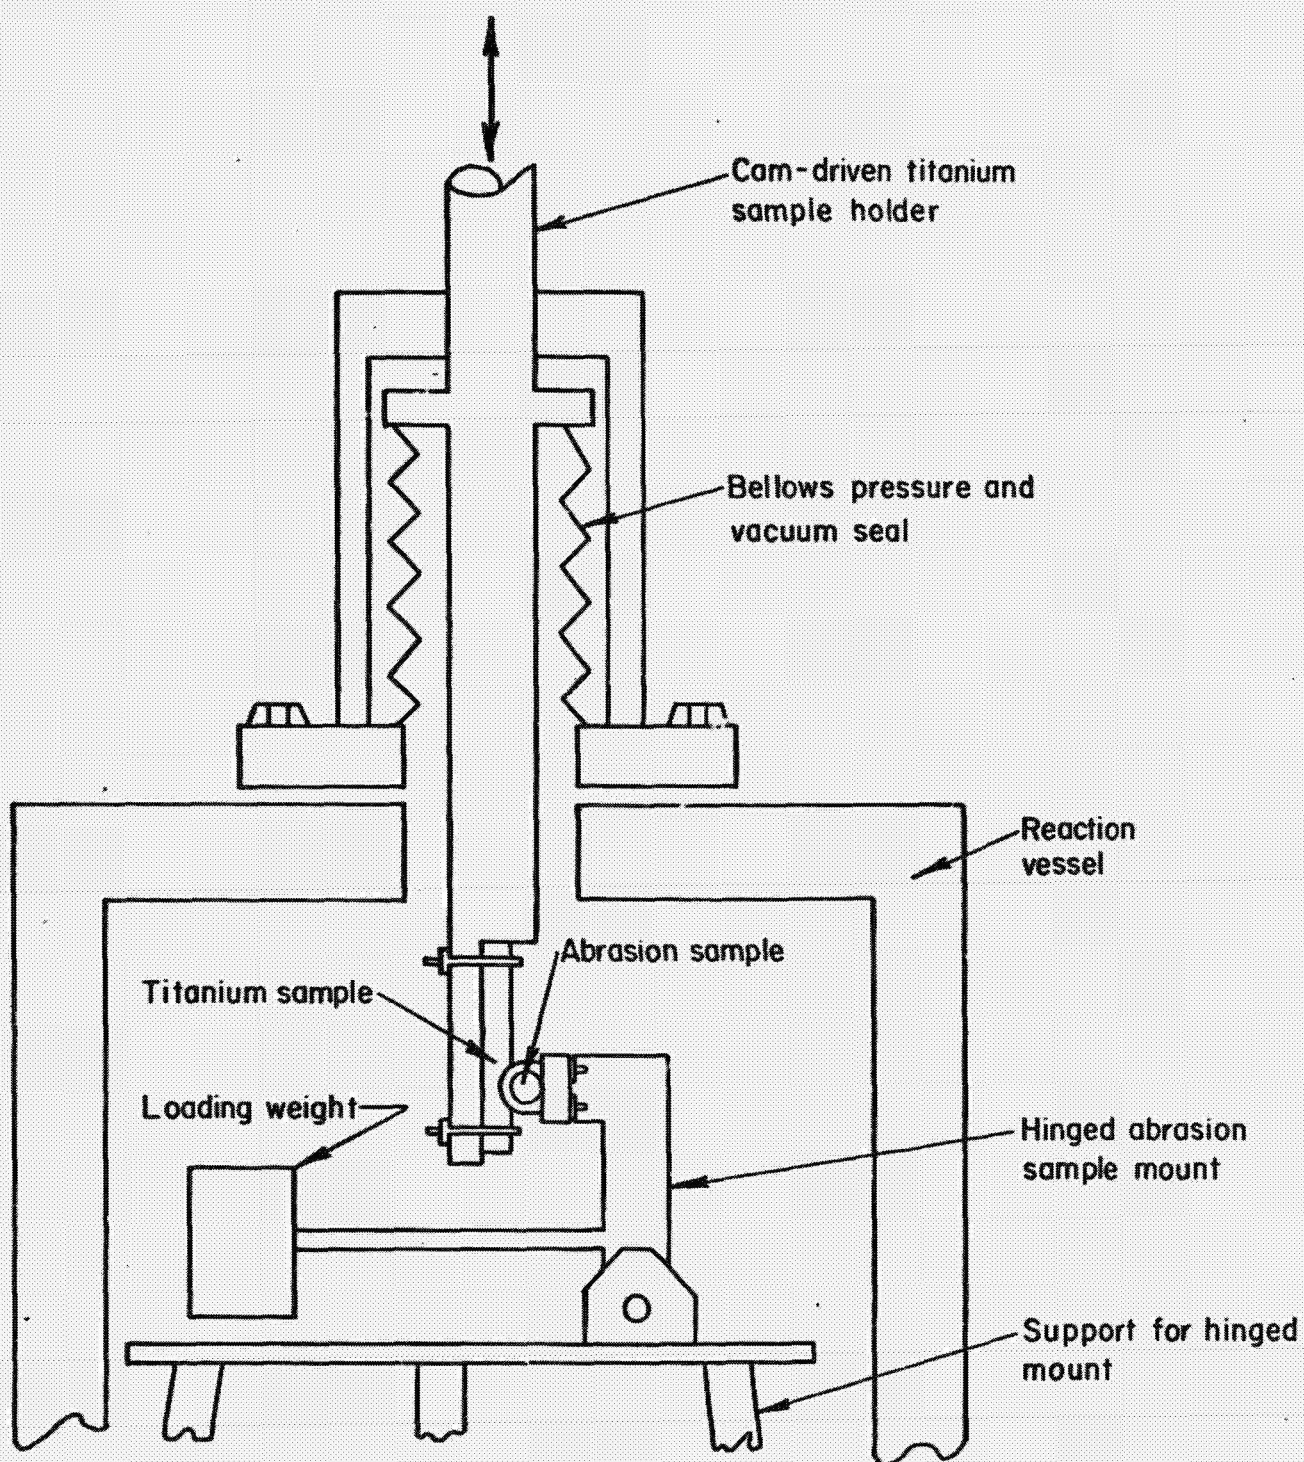
FIGURE 8. DRAWING OF DEVICE TO PERMIT GALLING OF SAMPLE IN A HYDROGEN ATMOSPHERE

The same chamber was used for galling the samples while under hydrogen pressure by means of the equipment shown in Figure 8. (This equipment is shown in place on the stainless steel chamber in Figure 7.) The test sample was mounted on the driven rod and the galling or abrading material on the hinged mount. Reciprocating motion to produce galling was

transmitted from a 30-rpm motor through a cam to the bellows-sealed sample holder. A single wear scar was produced on the sample and a notch was worn into the stationary galling material.

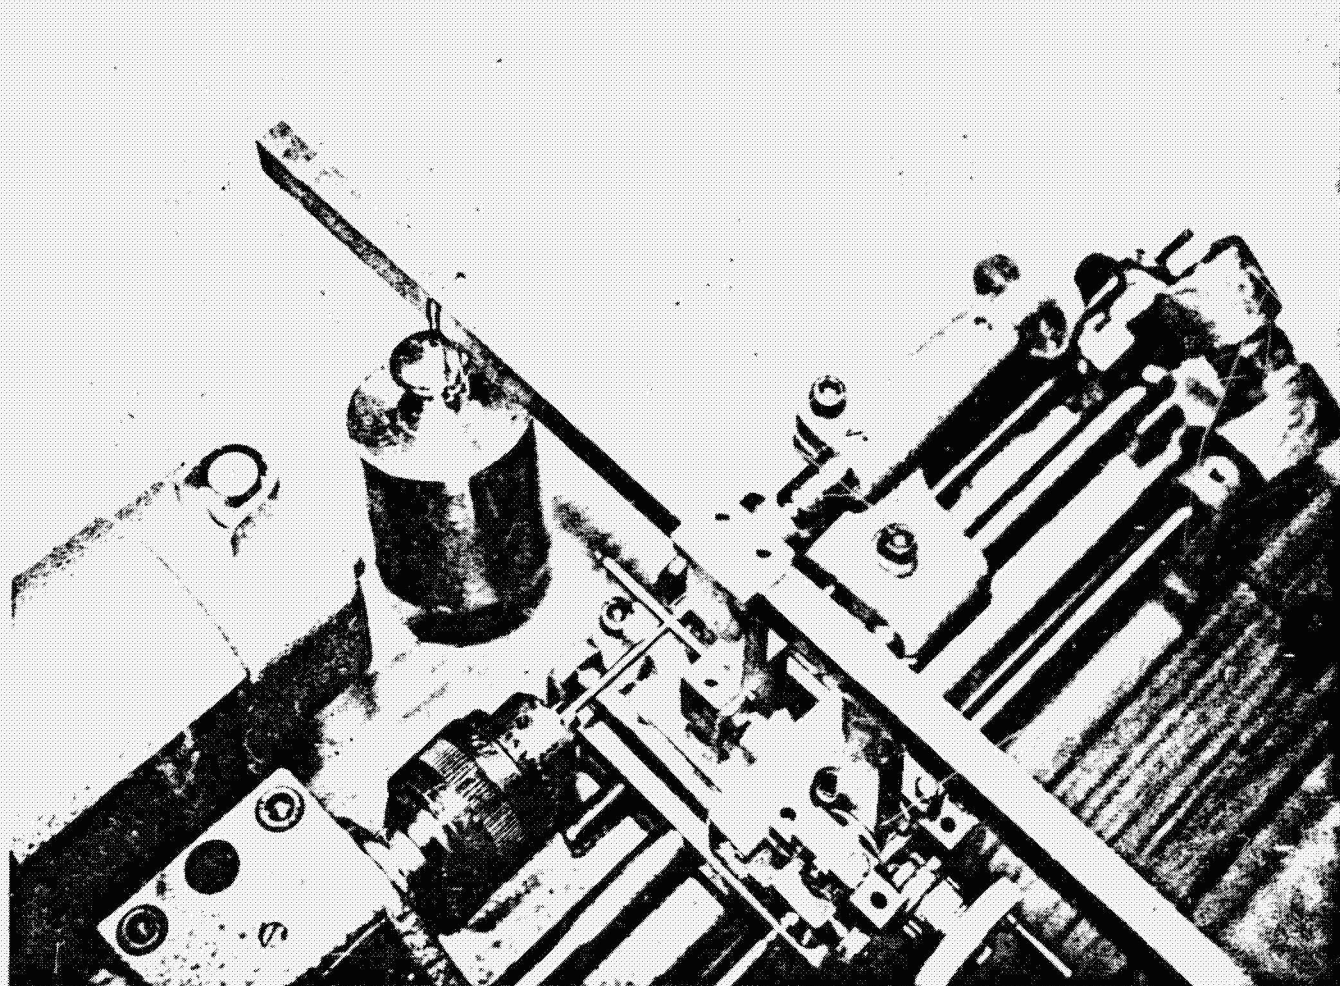
FIGURE 10. METHOD USED FOR GALLING SAMPLES IN A SMALL LATHE

To gall a cylindrical titanium sample evenly and with a force which was reproducible, a small lathe was used. The tool holder section was modified so that a length of rod, to be used as galling material, could be brought to bear on the sample with a definite load. The lathe had an automatic feed attachment which permitted an even galling over nearly the entire length of the sample while it was being rotated.

The galling load could be changed by suspending various weights at varying distances along a fulcrum arm to which the galling material was attached. This equipment is shown in Figure 10. Most of the experimental runs were made using a 2-pound weight attached to the fulcrum which was equivalent to a 7-pound load acting on the sample.

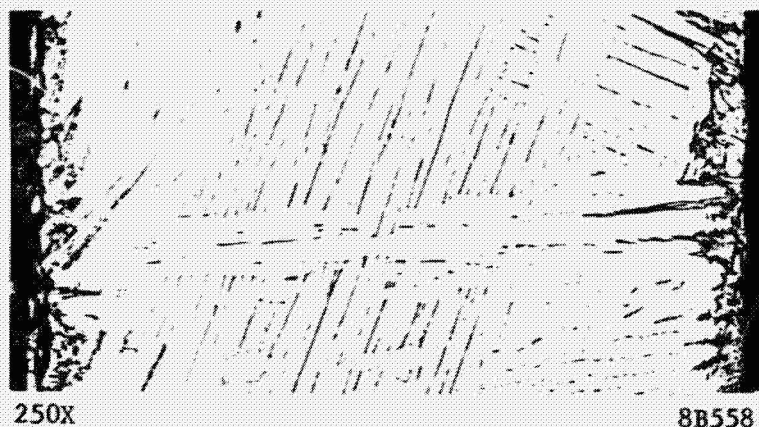
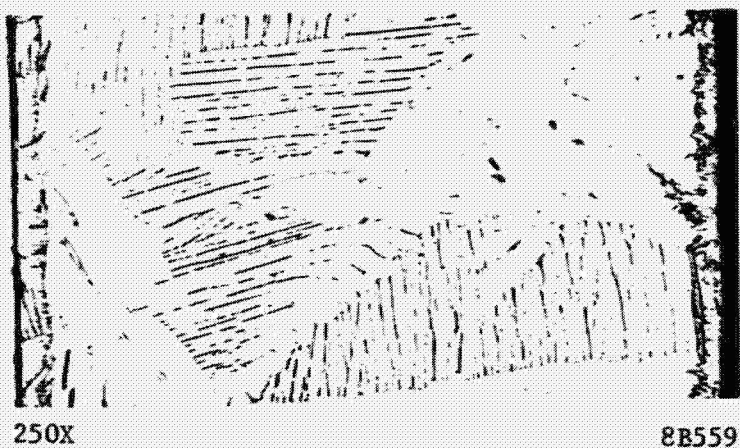
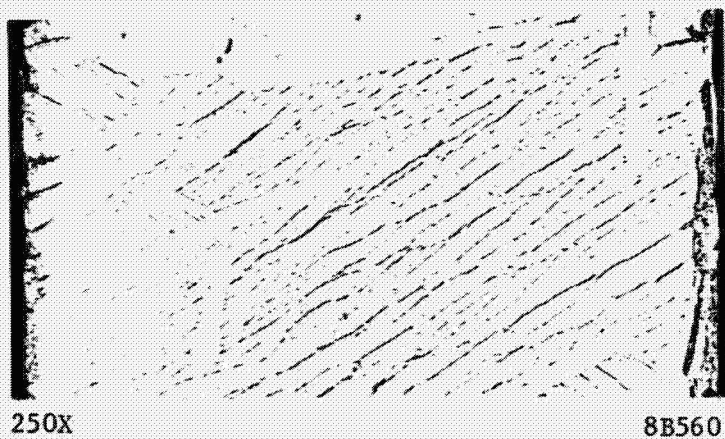
FIGURE 11. THE EFFECT OF HYDROGEN PRESSURE ON HYDRIDE-LAYER THICKNESS

- (a) Exposed to 1000 psig hydrogen pressure for 76-1/2 hours, average hydride thickness 0.73 mil (note deep penetration)

- (b) Exposed to 590 psig hydrogen pressure for 95 hours, average hydride thickness 0.61 mil

- (c) Exposed to 300 psig hydrogen pressure for 96 hours, average hydride thickness 0.49 mil

All three samples were acicular Ti-50A and were reacted at 99 F.

Temp., F	Hydrogen Exposure		Thickness of Hydride, mils
	Pressure, psig	Time, hr	
95-105	300	75	0.37
95-105	300	96	0.49
95-105	590	95	0.61
95-105	1000	76-1/2	0.73

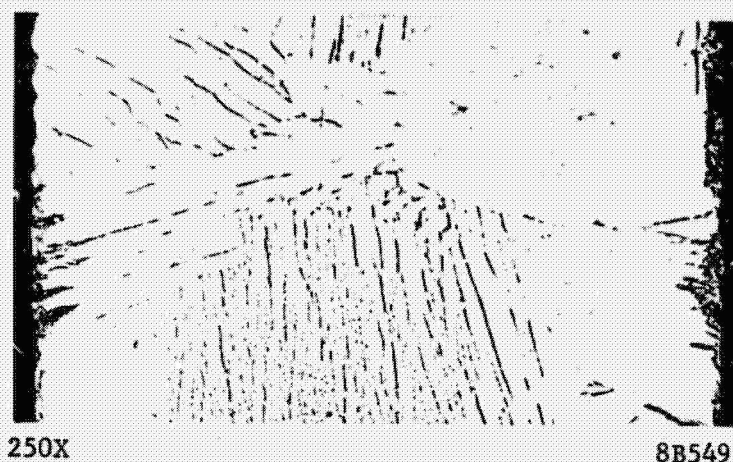
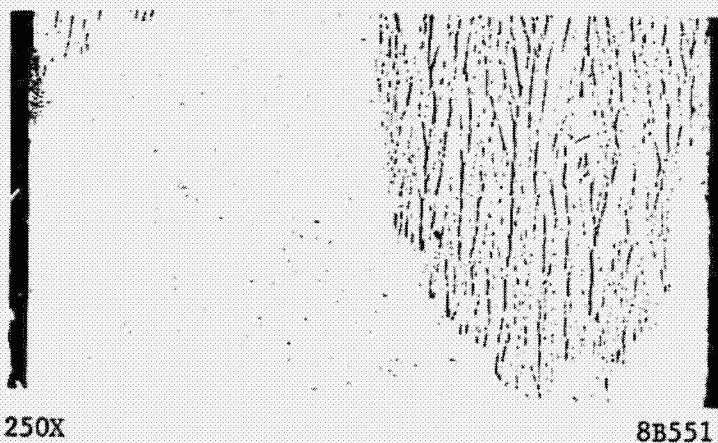
FIGURE 12. THE EFFECT OF EXPOSURE TO AIR AFTER ABRADING AND PRIOR TO EXPOSURE TO HYDROGEN

- (a) Exposed to air 5 minutes after abrading and before exposure to hydrogen.

- (b) Exposed to air 1 hour after abrading and before exposure to hydrogen.

- (c) Exposed to air 4 hours after abrading and before exposure to hydrogen.

All three samples were acicular Ti-50A and were reacted with 300 psig hydrogen for 24 hours at 99 F.

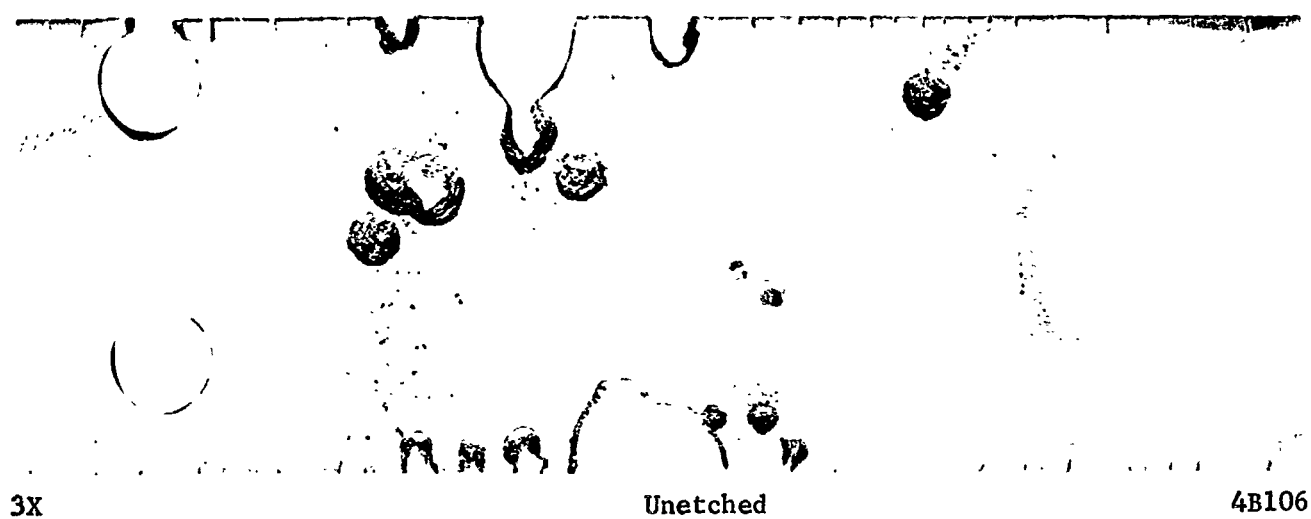
FIGURE 13. ACICULAR Ti-6Al-4V SHOWING RESULT OF HYDRIDING UNDER STRESS FOR 138 HOURS AT 80 F

Pitting occurred as a result of swelling of hydride.

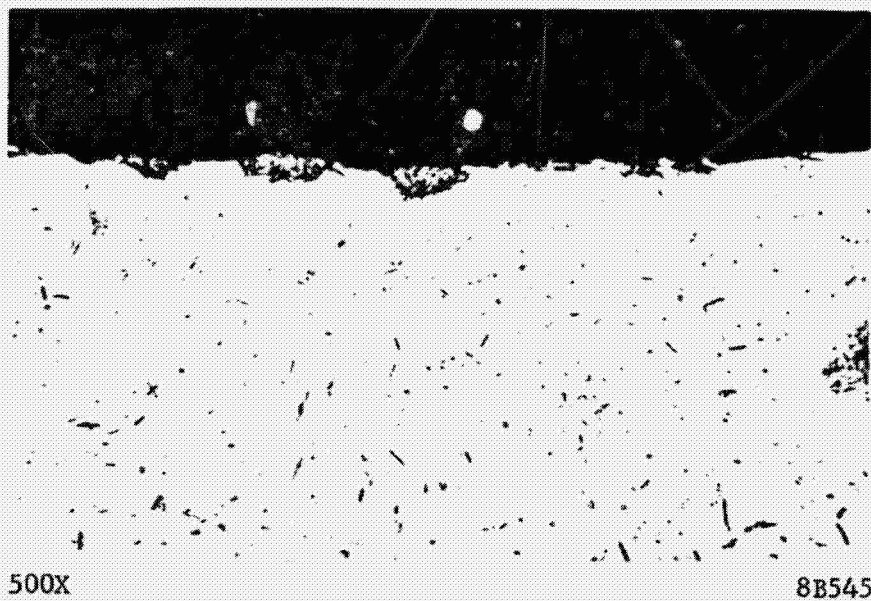
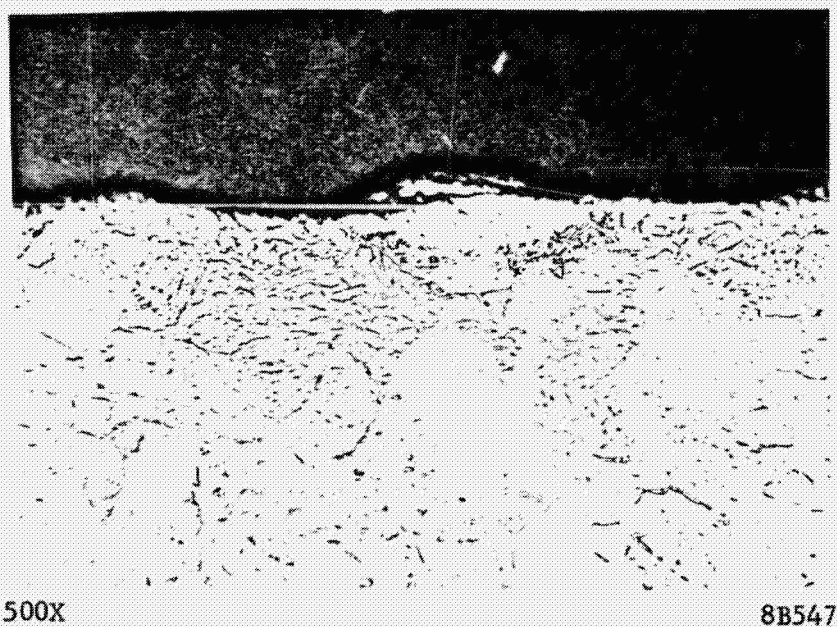
FIGURE 15. HYDRIDING OF THE INSIDE OF THE UNALLOYED TITANIUM TUBING

(a) Reacted in the "as-received" condition with 300 psig hydrogen for 24 hours at 99 F

(b) Galled with H-11 steel before reacting with 300 psig hydrogen for 24 hours at 99 F

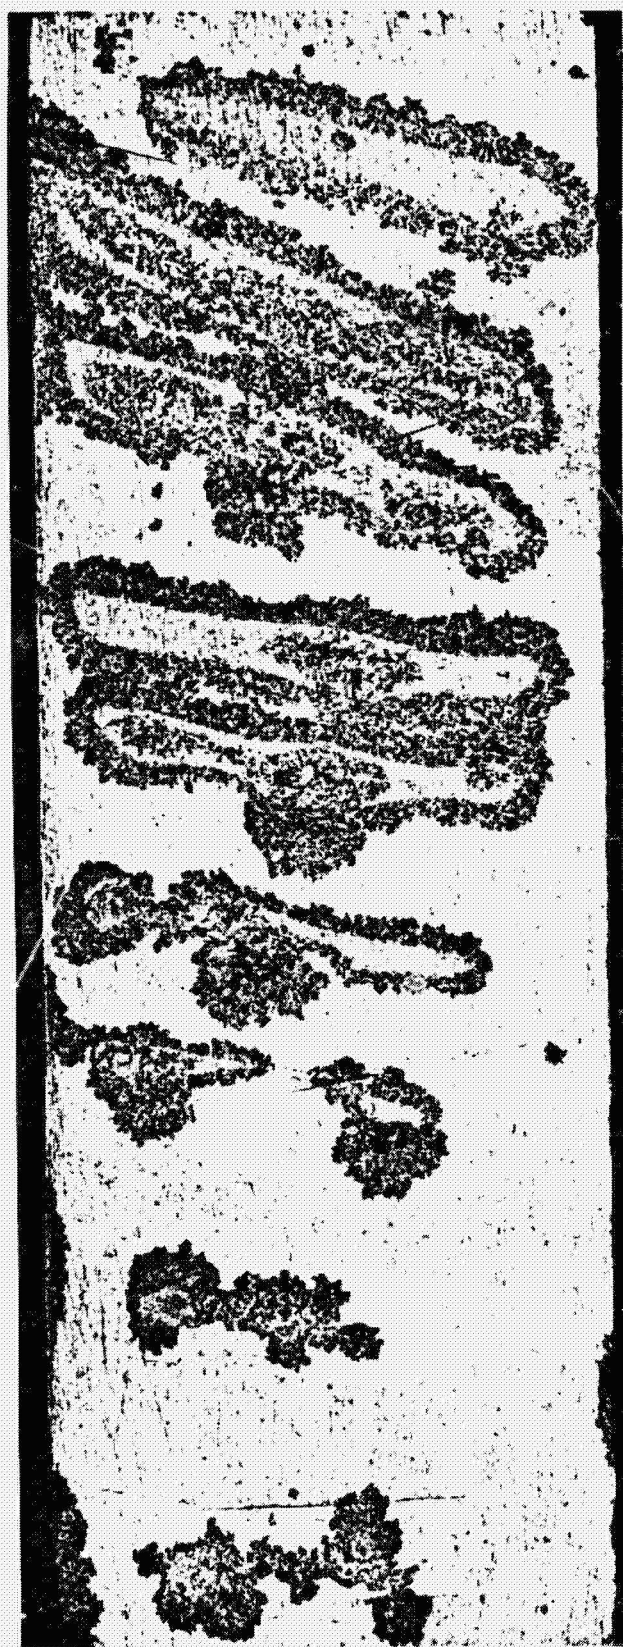
FIGURE 16. MACROVIEW OF Ti-50A  
IN CONTACT WITH NICKEL  
RIBBON

Titanium hydride formed under turns of nickel ribbon during 22-hour exposure to one atmosphere of hydrogen at 300 F. Cracks indicating embrittlement of the titanium appeared when the sample was flattened slightly for photographing.

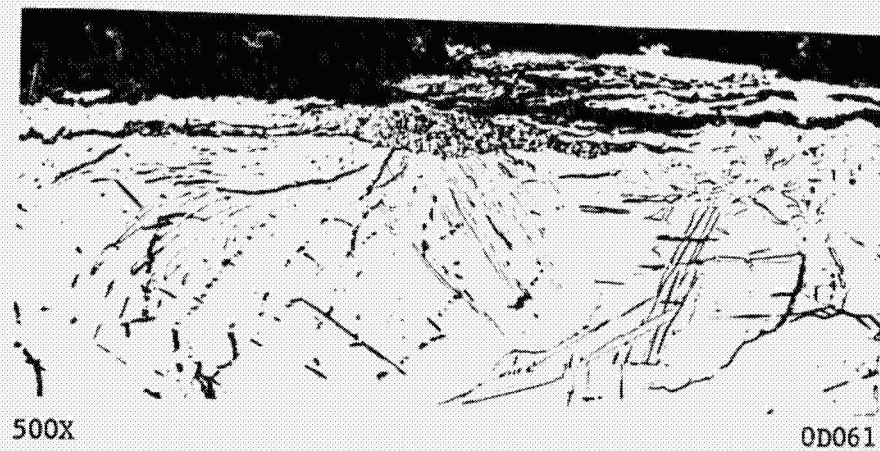
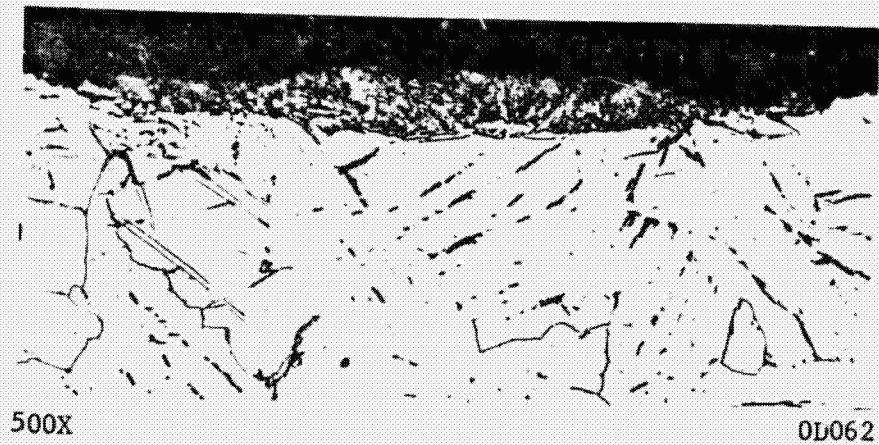
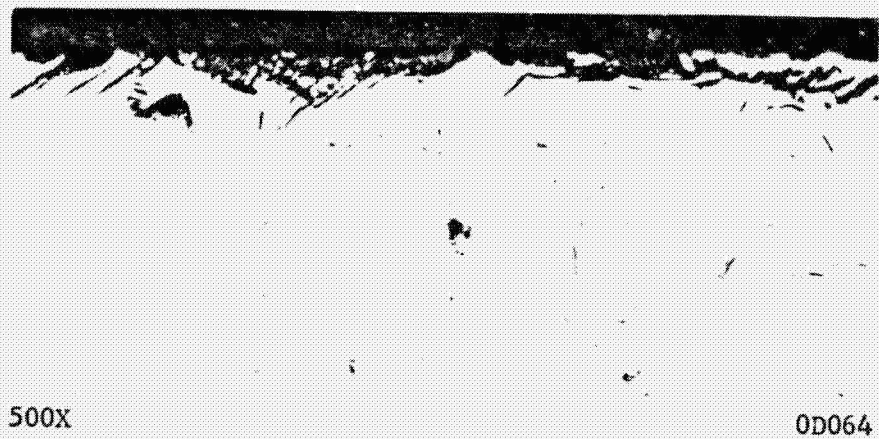
FIGURE 17. TYPICAL HYDRIDE FORMED UNDER GALLED  
AND ABRADED AREAS OF Ti-50A

(a) Ti-50A galled  
with Ti-50A

(b) Ti-50A galled  
with H-11 steel

(c) Ti-50A abraded  
with 240-grit  
silicon carbide  
paper

In nearly every case, samples which had been galled reacted only in or along the galled line or scratch. Even those samples which were abraded before galling and vacuum annealed after galling (for atmospheric hydrogen exposure) hydrided predominantly in the galled areas. Typical hydride formed under galled areas and under silicon-carbide abraded areas is illustrated in Figure 17.

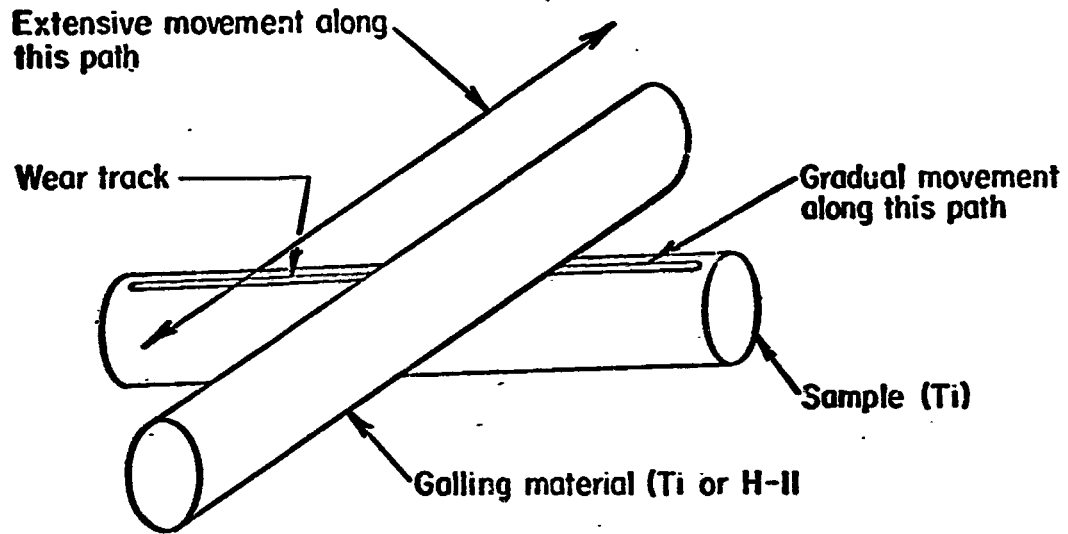
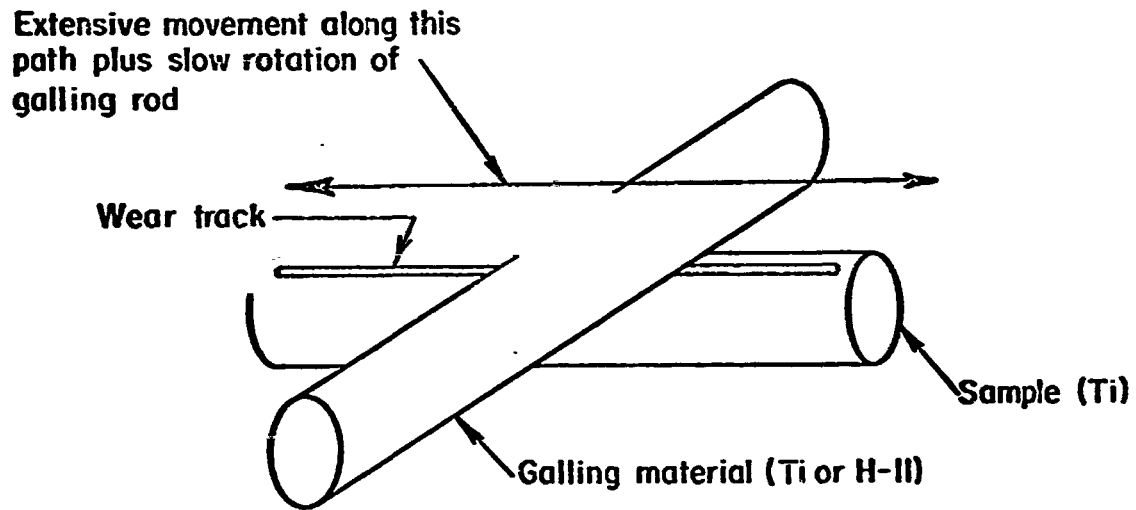
FIGURE 18. TWO PROCEDURES USED TO GALL TITANIUM SAMPLES

a. Transverse galling

b. Longitudinal galling

The effect of three methods of galling, transverse reciprocating, longitudinal reciprocating, and by rotational galling on a lathe, on the reaction between hydrogen and titanium at 300 psig pressure is summarized in Table 18. Figure 18 illustrates the transverse and longitudinal galling procedures, while the lathe galling method is described in the section on experimental equipment and technique. It is apparent from Table 18 that a slight increase in hydrogen reaction results when the sample is galled transversely compared to a longitudinally galled sample. The quantity of hydride formed on a lathe-galled sample lies about midway between that of transverse and longitudinally galled ones. This difference in absorption with technique used is considerably larger when the sample is contaminated with oil during galling. (Refer to Tables 18 and 19 and to the section on contaminants.)

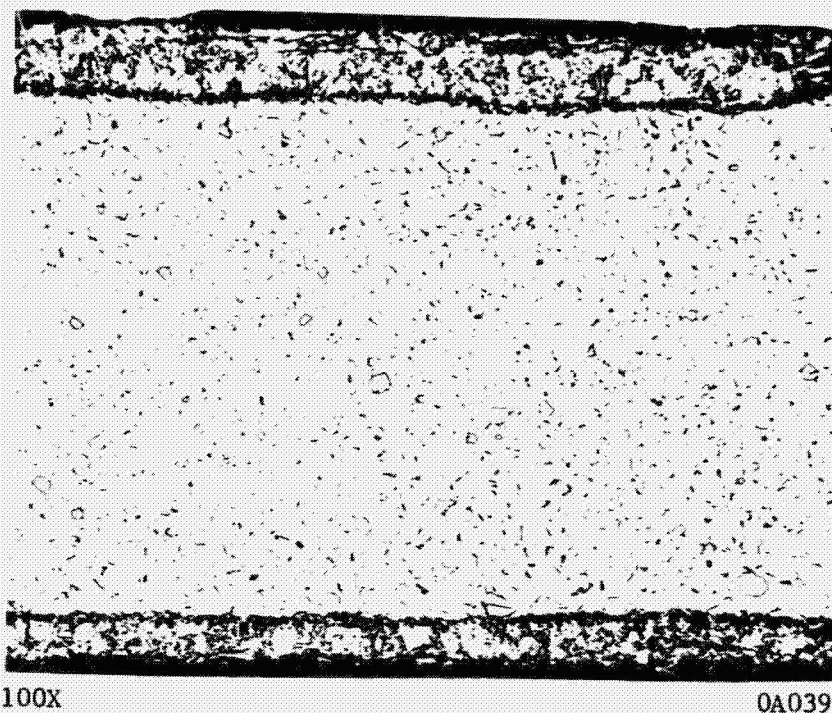
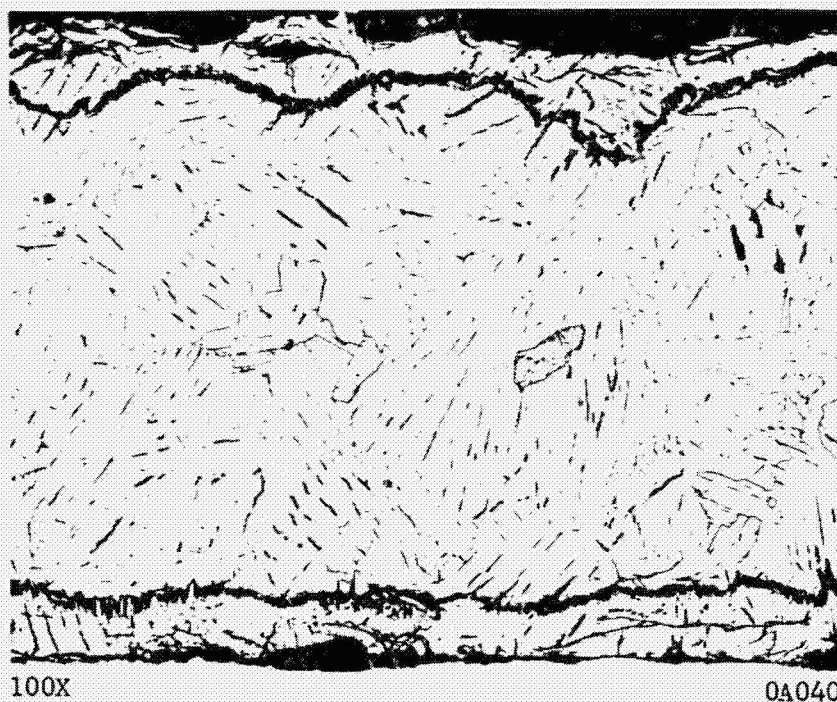
FIGURE 20. A COMPARISON OF HYDRIDE FORMED ON Ti-50A HAVING EQUIAXED AND ACICULAR MICROSTRUCTURE

(a) Hydride formed on equiaxed Ti-50A after a 10-hour exposure to hydrogen at 300 psig and 300 F

(b) Hydride formed on coarse acicular Ti-50A after a 10-hour exposure to hydrogen at 300 psig and 300 F

Time of Exposure, hr	Condition	Thickness of Hydride Layer, Average (mils)
10	Fine grained equiaxed	2.5
"	Coarse acicular	3.5
"	Fine acicular	2.8
100	Fine grained equiaxed	3.0
"	Coarse acicular	4.5
"	Fine acicular	2.8

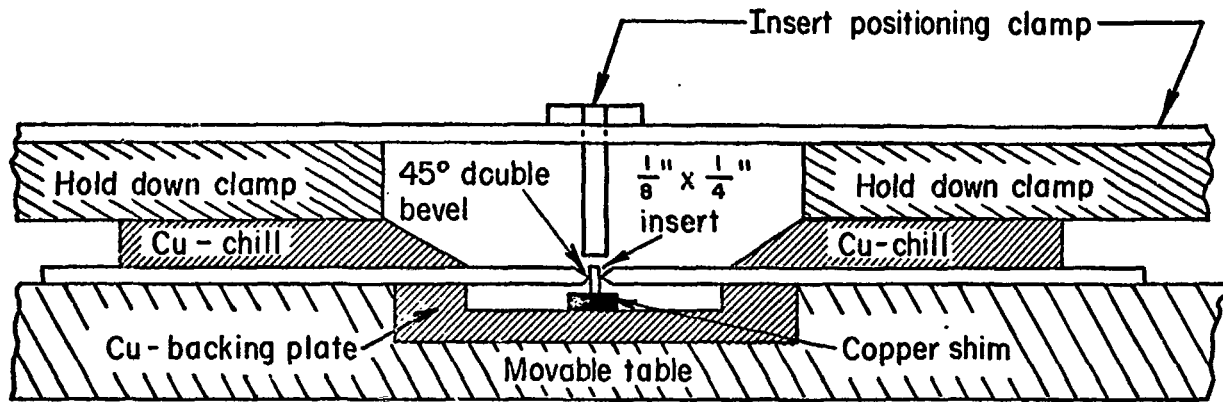
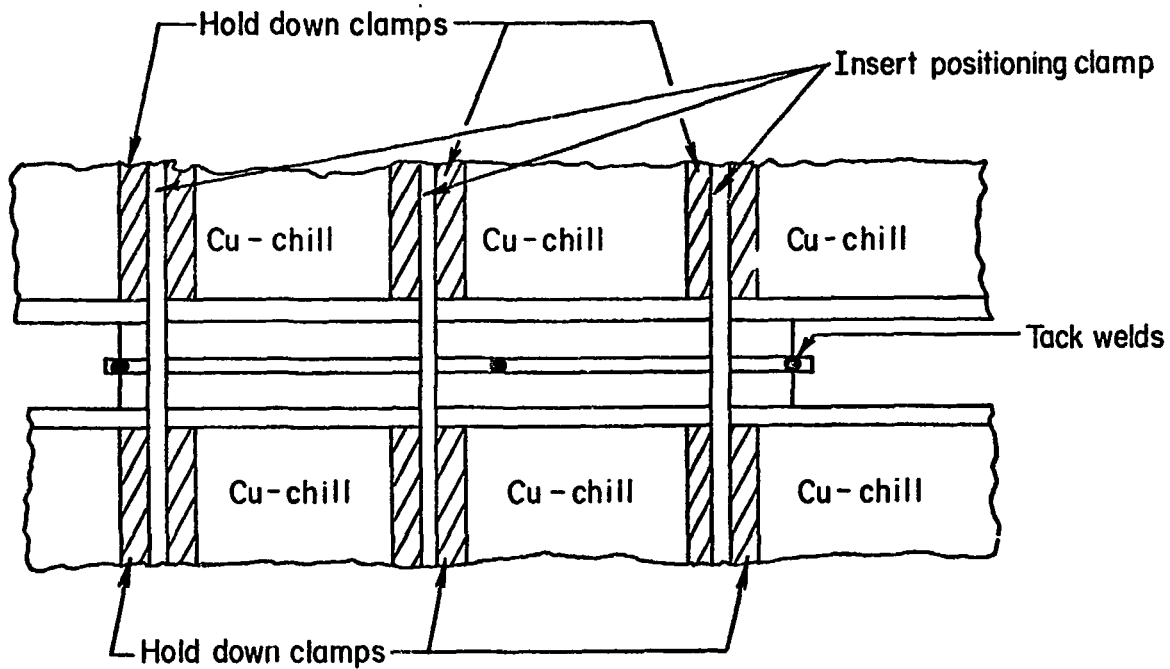
FIGURE 22. JOINT CONFIGURATION AND TOOLING  
FOR PRODUCTION OF THE WELDMENTS

The titanium alloy plates and filler metal insert were inserted into the chamber and the tooling was clamped into place. The table was then slowly moved from end to end to check for proper alignment of the tungsten electrode along the insert center line. After final alignment, the chamber was then purged and back-filled with the high-purity argon to a slight positive pressure. Tack welds were then placed in the middle and at each end of the insert. The insert positioning clamps and copper shims were removed and the tacked assembly reclamped and realigned. The top weld was then made along the length of the plates. The first pass melted the top portion of the insert achieving about 55 percent penetration. The partially welded assembly was then removed from the tooling, rotated 180 degrees about the longitudinal weld axis, reclamped, and realigned. The second pass weld was then made to complete the joint.
